Fill Removal and Wetlands Restoration Plan

for the matter of
Civil Action No. 2:17-cv-01244-DAK
Saratoga Springs Harbor, Utah County, Utah

FINAL September 11, 2018

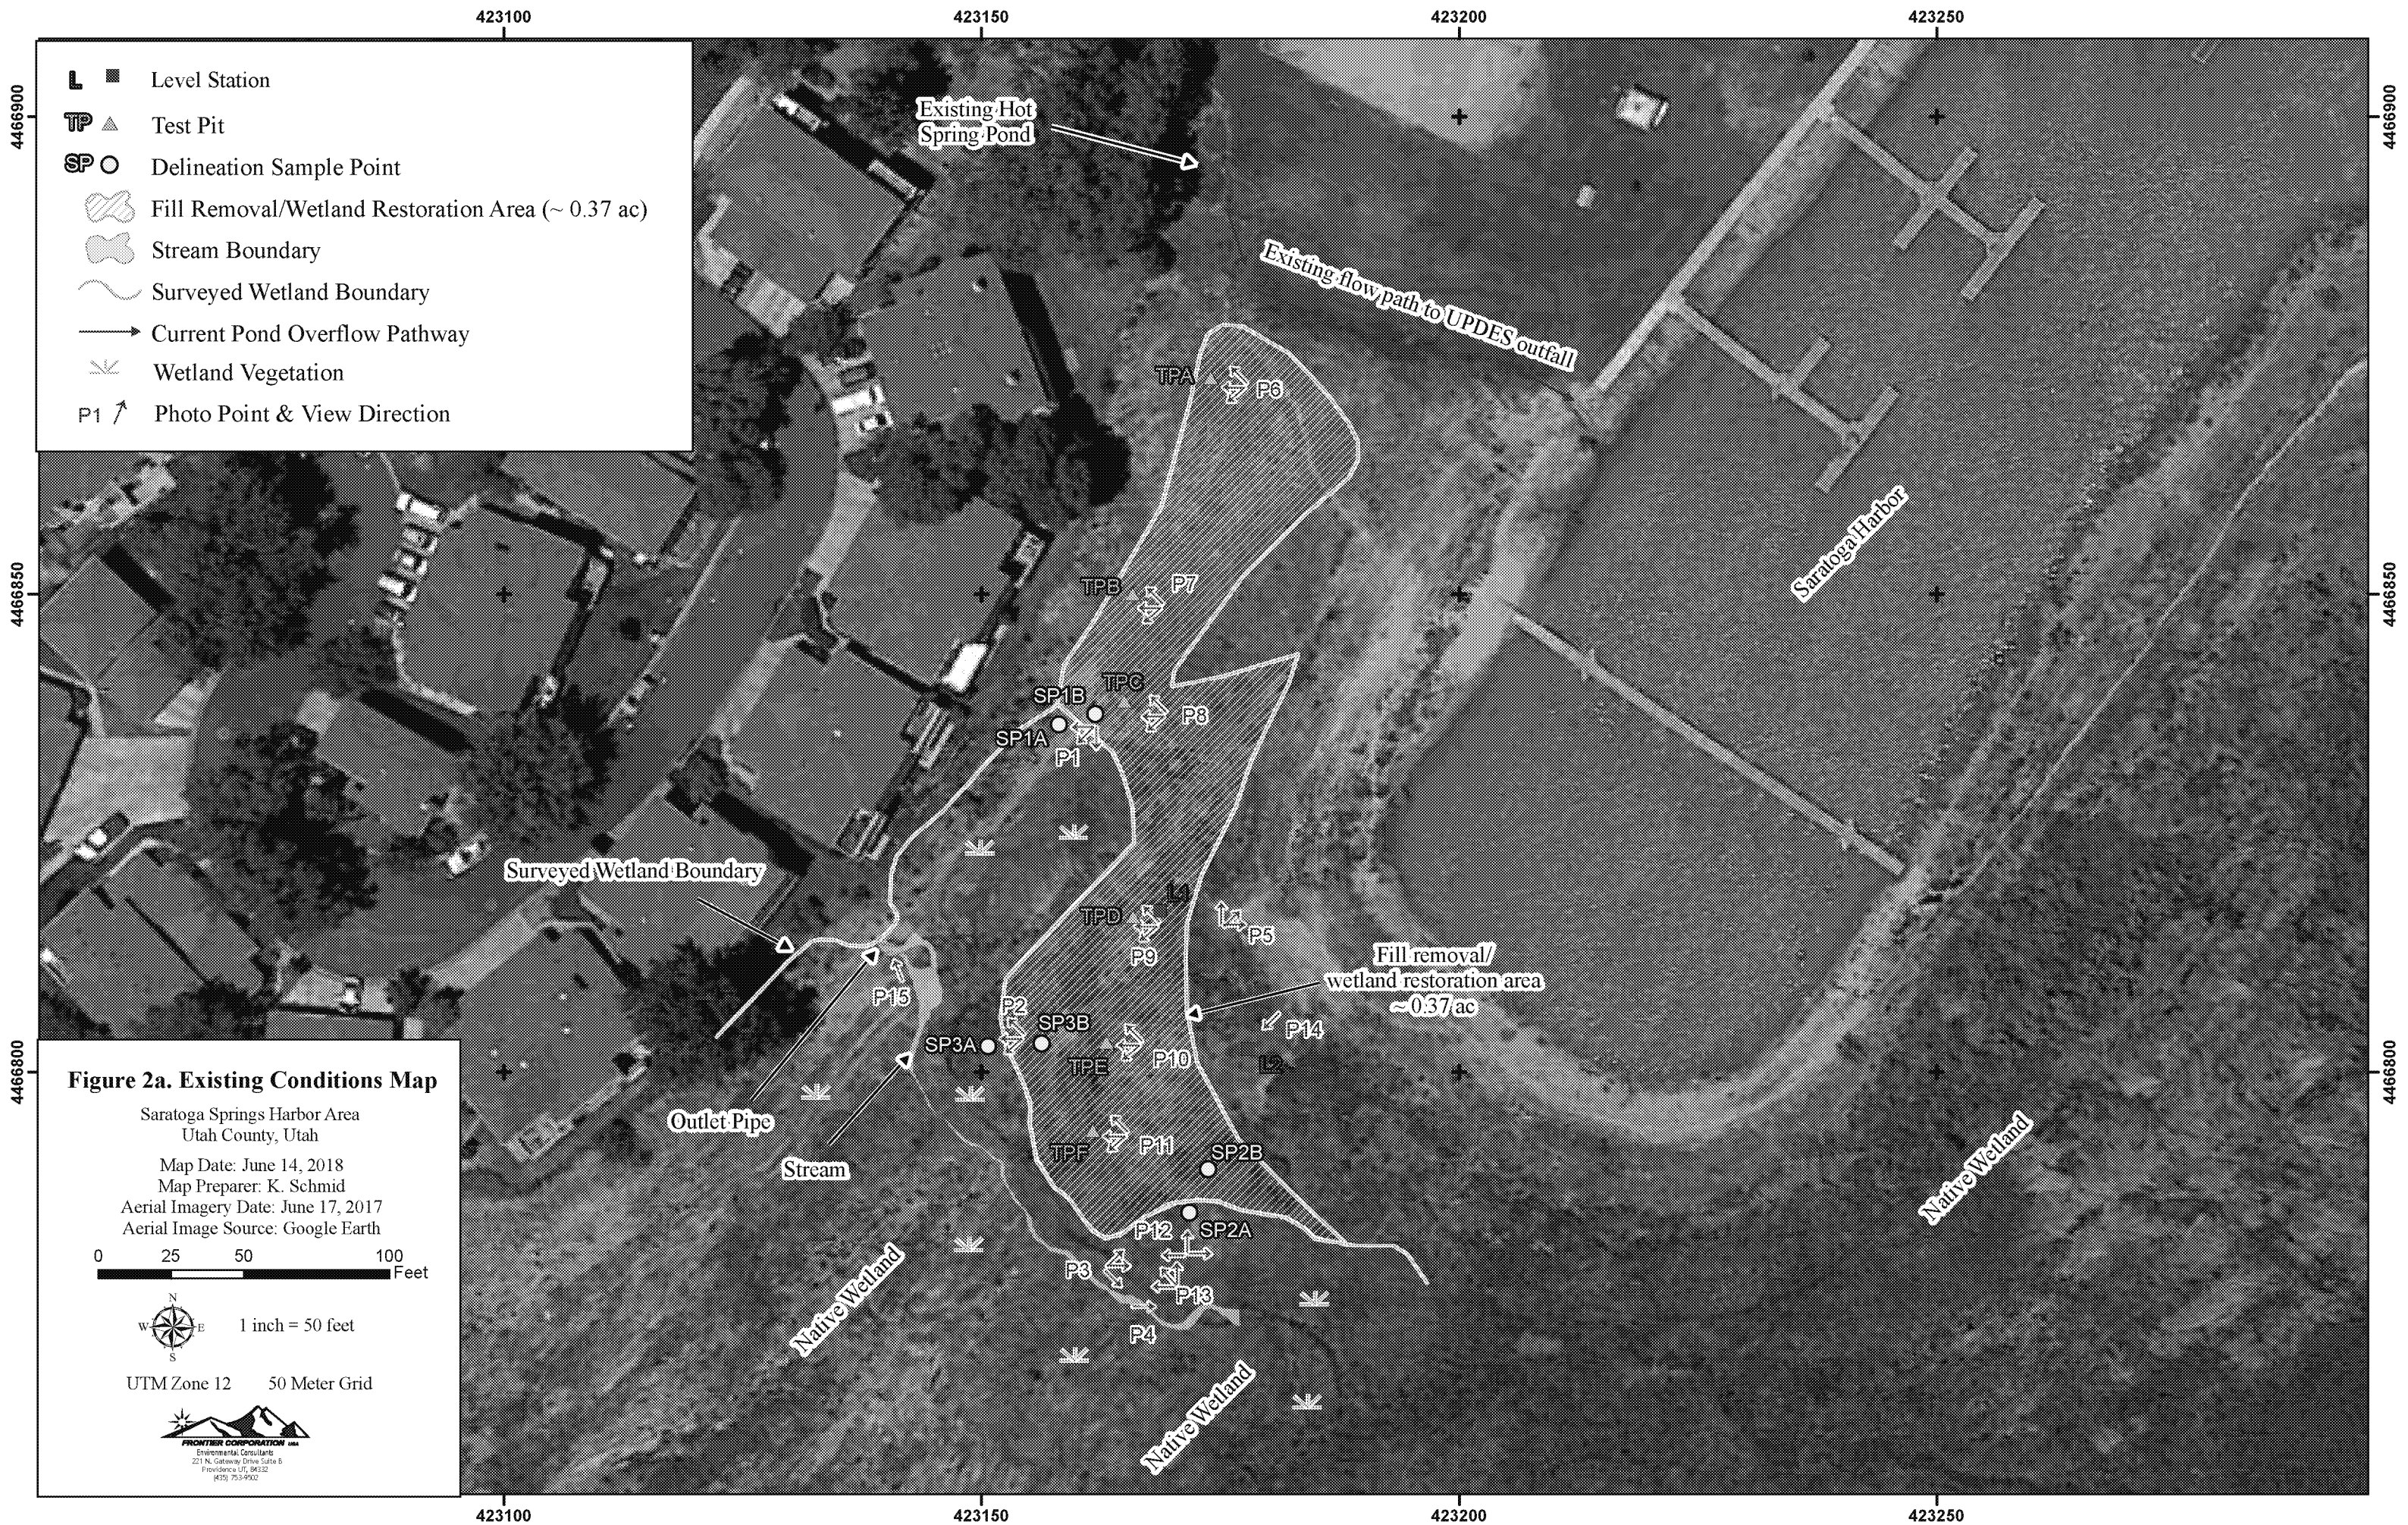
Figure 1. General Site Location Map.	3
Figure 2a Existing Conditions Map.	5
Figure 2b. Existing Conditions Map – Elevation Differences.	6

The existing wetlands adjacent to the west sides of the fill removal area are dominated by invasive, non-native common reed (aka Phragmites) (*Phragmites australis*). In fact, Phragmites is spreading rhizomatously from the wetlands on to adjacent fill slopes where upland sample points were conducted. (See delineation sample points SP1A, SP1B, SP3A and SP3B in Appendix B and as shown on Figure 2a.)

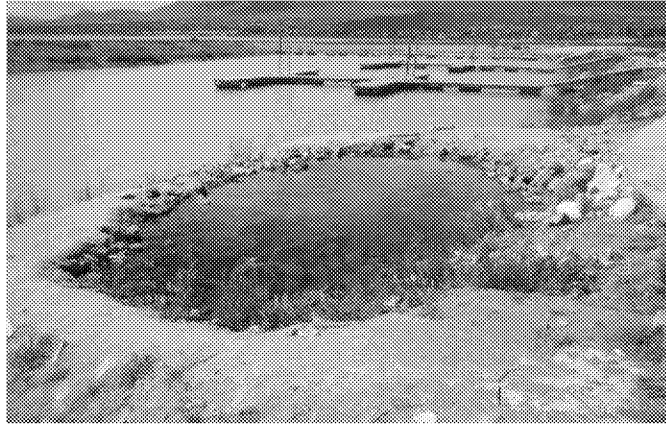
Existing rock retainer wall that will be removed to establish free flow into harbor.

Overflows (pink arrow in Appendix A) from natural hot springs are currently captured by a rock retainer (#4 in Appendix A) wall located on the south side of the harbor boat ramp.

- A. The existing rock retainer wall will be removed from the hot spring outlet to establish free flow into the harbor.
- B. The free flow of hot spring water into the harbor will help maintain ice-free water in the harbor during the winter months.

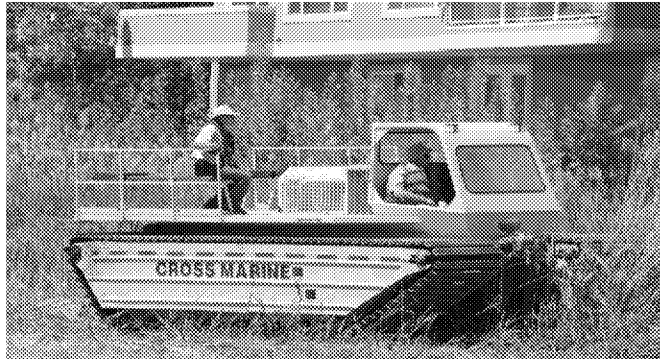
Photo of Cross Marine using a Marsh Master tracked amphibious machine to trample and destroy dead Phragmites.

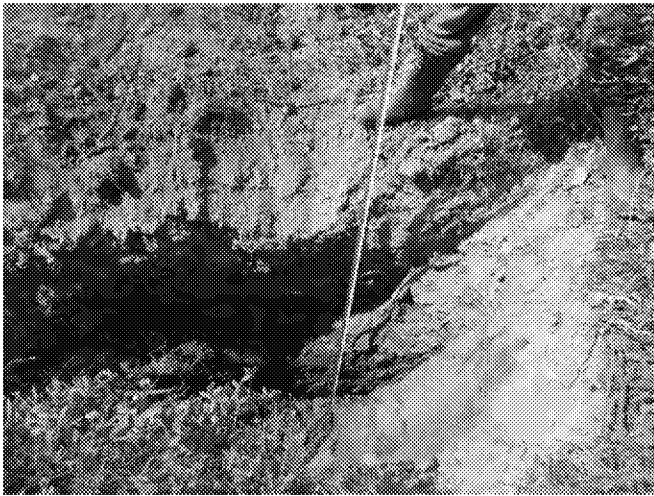
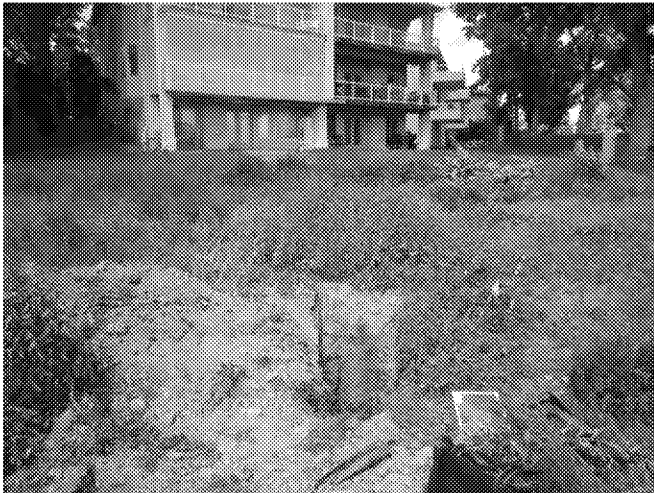
Photo 6a. Test Pit A.

Photo 6b. Test Pit A overview.

Test Pit: A		
Location Details: Fill Removal Area		
Projection: Latitude/ Longitude		Datum: WGS 1984
Coordinates: 40.348874/-111.904641		
Soil Profile		
Depth (Feet)	Texture	Remarks
0-3.0	Sandy, Silt, Loam	
3.0-3.5	Gravel	
3.5-4.2	Gravel + Silt	
4.2-5.0	Woody Debris/ Concrete	Fencepost ?
5.0-5.5	Clay	Saturation at 5.0 ft.
5.5-6.2	Gray Sand	Water table at 6.2 ft.
Vegetation		
Common Name	Scientific Name	Indicator Status
Clasping pepperweed	Lepidium perfoliatum	FACU
Broad-leaf pepperweed	Lepidium latifolium	FAC
Yellow sweet-clover	Melilotus officinalis	FACU
Cheatgrass	Bromus tectorum	UPL
Lamb's-quarters	Chenopodium album	FACU
Bind weed	Convolvulus arvensis	FACU
Hydrology		
	Depth from surface	Date Inspected
Saturation	5.0 ft.	6/1/2018
Water Table	6.2 ft.	6/1/2018

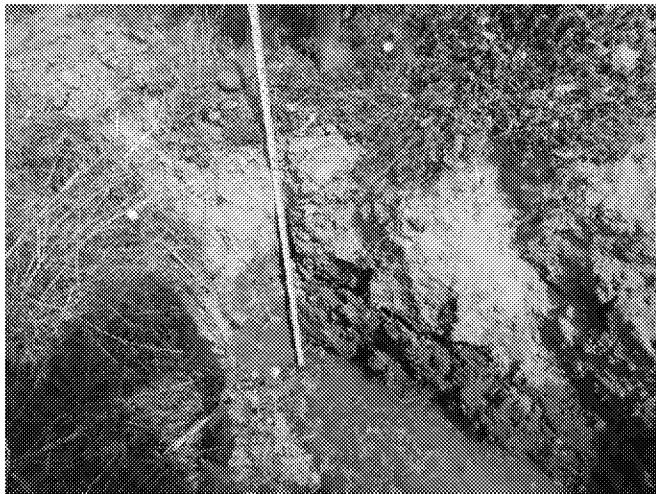
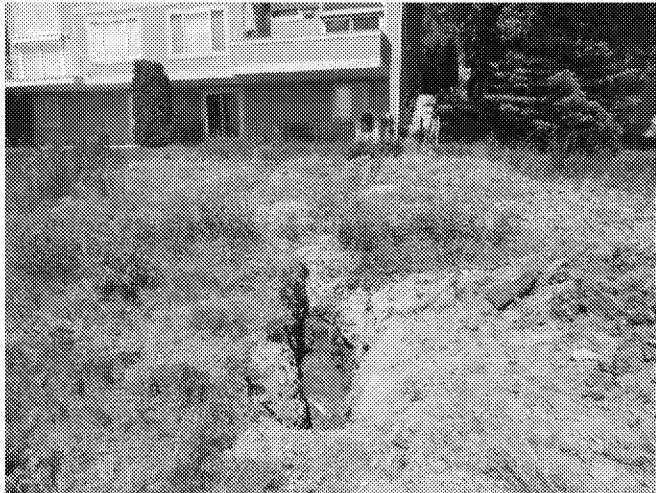
Photo 7a. Test Pit B.

Photo 7d. Test Pit B overview.

Test Pit: B		
Location Details: Fill Removal Area		
Projection: Latitude/ Longitude		Datum: WGS 1984
Coordinates: 40.348669/ -111.904735		
Soil Profile		
Depth (Feet)	Texture	Remarks
0-2.1	Sandy + Silt + Loam	Friable Soil
2.1-3.2	Gravel + Silt + Cobbles	
3.2-4.4	Clay	Saturated at 3.5 ft.
4.4-4.8	Silt + Loam	Water table at 4.0 ft.
Vegetation		
Common Name	Scientific Name	Indicator Status
Clasping pepperweed	Lepidium perfoliatum	FACU
Broad-leaf pepperweed	Lepidium latifolium	FAC
Cheatgrass	Bromus tectorum	UPL
Lamb's-quarters	Chenopodium album	FACU
Hydrology		
	Depth from surface	Date Inspected
Saturation	3.5 ft.	6/1/2018
Water Table	4.0 ft.	6/1/2018

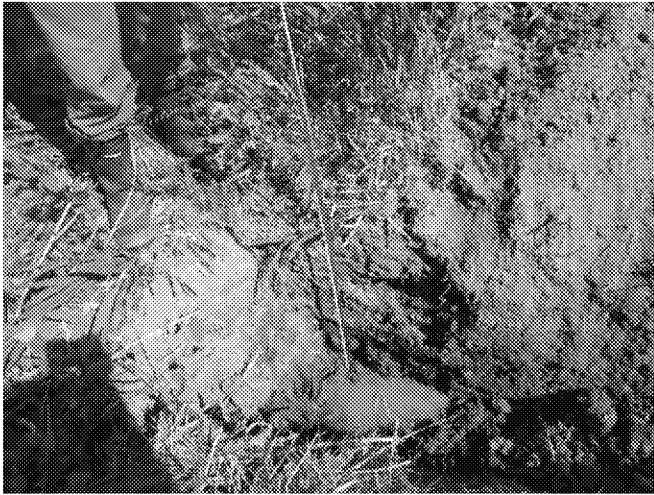
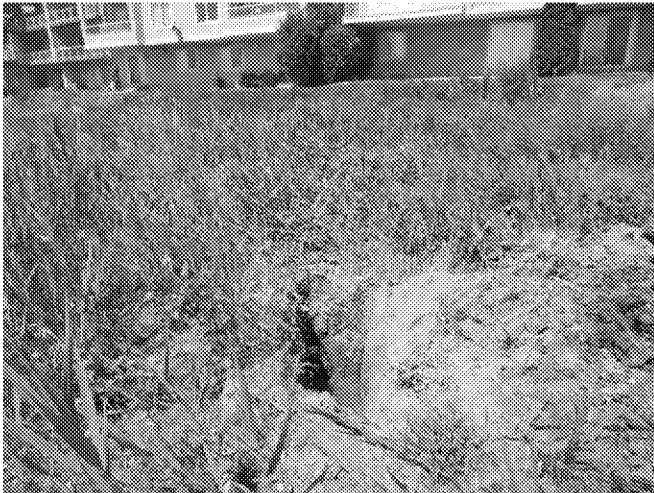
Photo 8a. Test Pit C.

Photo 8b. Test Pit C overview.

Test Pit: C		
Location Details: Fill Removal Area		
Projection: Latitude/ Longitude		Datum: WGS 1984
Coordinates: 40.348568/ -111.904743		
Soil Profile		
Depth (Feet)	Texture	Remarks
0-3.1	Sandy + Silt + Loam + Roots	Roots zone at surface.Phragmites spreading rhizomatously
3.1-4.1	Clay + Cobbles	Clay is dark gray with black streaking. Saturated in lower portion.
4.1 +		Water table at 3.9
Vegetation		
Common Name	Scientific Name	Indicator Status
Clasping pepperweed	Lepidium perfoliatum	FACU
Cheatgrass	Bromus tectorum	UPL
Lamb's-quarters	Chenopodium album	FACU
Common reed	Phragmites australis	FACW
Field brome	Bromus arvensis	FACU
Crested wheatgrass	Agropyron cristatum	UPL
Hydrology		
	Depth from surface	Date Inspected
Saturation	3.1 ft.	6/1/2018
Water Table	3.9 ft.	6/1/2018

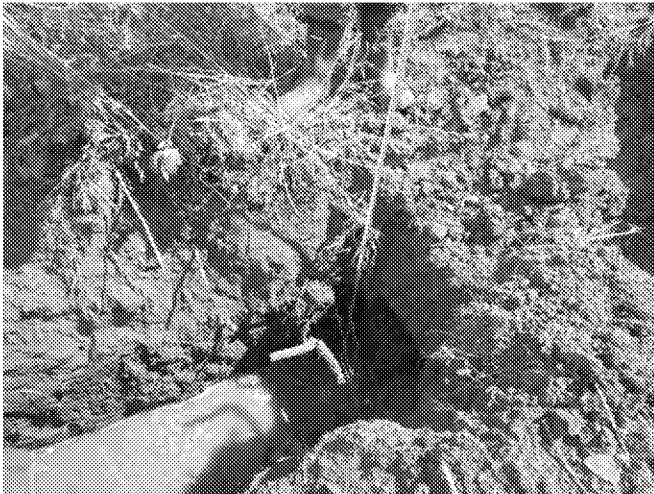
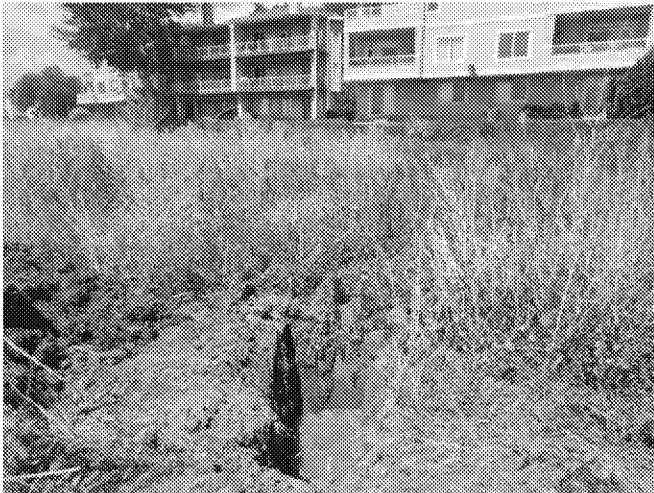
Photo 9a. Test Pit D.

Photo 9d. Test Pit D overview.

Test Pit: D		
Location Details: Fill Removal Area		
Projection: Latitude/ Longitude	Datum: WGS 1984	
Coordinates: 40.348365/ -111.90473		
Soil Profile		
Depth (Feet)	Texture	Remarks
0-2.0	Silt + Sand + Loam + Cobbles	Redox present at 1.5 ft.
2.0-2.6	Clay	Saturation at 2.5 ft.
2.6-3.7	Root Zone	Water table at 3.0 ft.
3.7-4.2	Gray Sand	
Vegetation		
Common Name	Scientific Name	Indicator Status
Lamb's-quarters	Chenopodium album	FACU
Common reed	Phragmites australis	FACW
Alfalfa	Medicago sativa	UPL
Creeping meadow-foxtail	Alopecurus arundinaceus	FAC
Hydrology		
	Depth from surface	Date Inspected
Saturation	2.5 ft.	6/1/2018
Water Table	3.0 ft.	6/1/2018

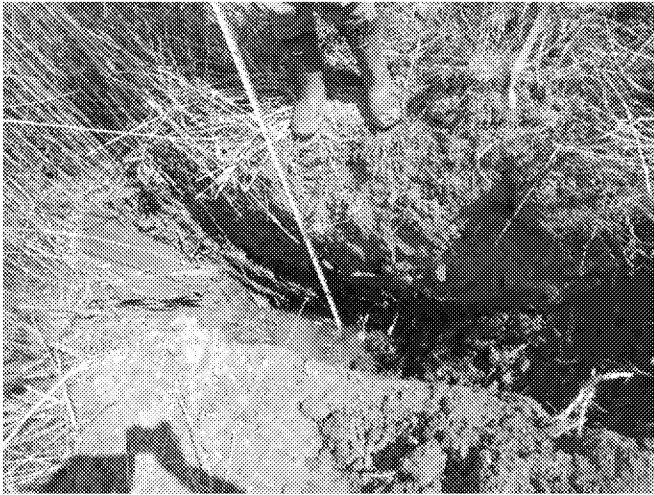
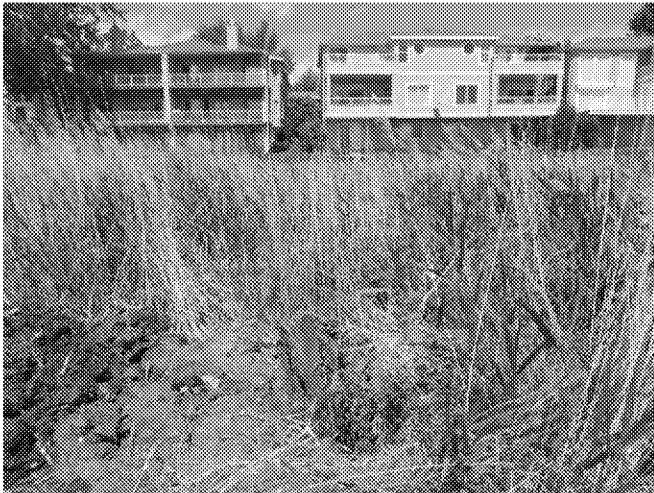
Photo 10a. Test Pit E.

Photo 10b. Test Pit E overview.

Test Pit: E		
Location Details: Fill Removal Area		
Projection: Latitude/ Longitude		Datum: WGS 1984
Coordinates: 40.348246/ -111.904761		
Soil Profile		
Depth (Feet)	Texture	Remarks
0-2.6	Fine Sand + Loam	Friable Soil
2.6-3.7	Clay	Saturation at 2.6 ft.
3.7-4.1	Fibrouse organic mat	Water table at 3.0 ft.
4.1-4.4	Gray Sand	
Vegetation		
Common Name	Scientific Name	Indicator Status
Common reed	Phragmites australis	FACW
Alfalfa	Medicago sativa	UPL
Bull thistle	Cirsium vulgare	FACU
Hydrology		
	Depth from surface	Date Inspected
Saturation	2.6 ft.	6/1/2018
Water Table	3.0 ft.	6/1/2018

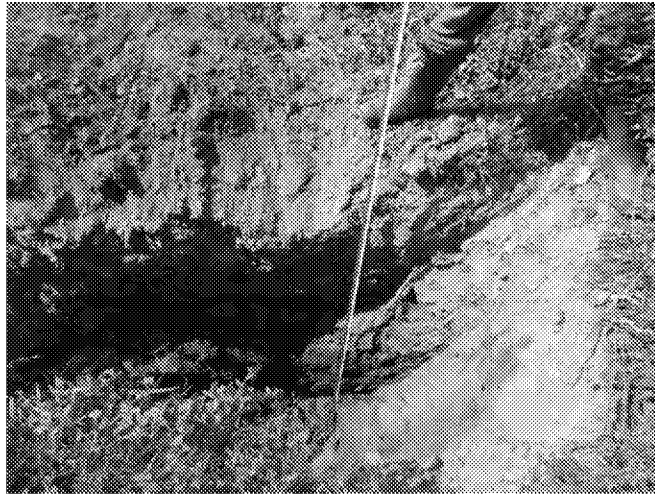
Photo 6a. Close-up of Test Pit A profile.

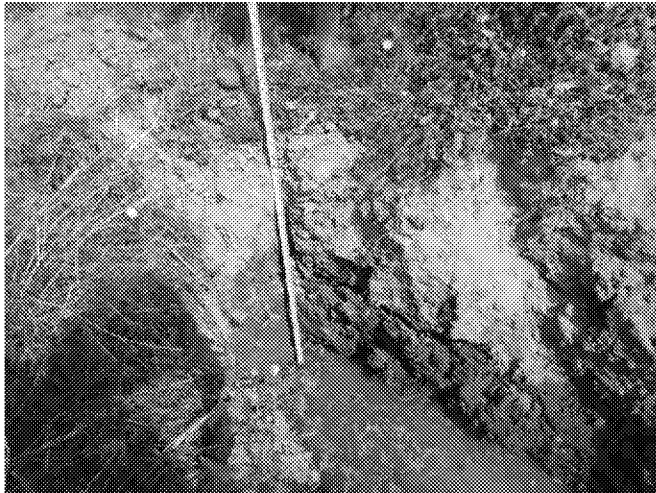
Photo 7a. Close-up of Test Pit B profile.

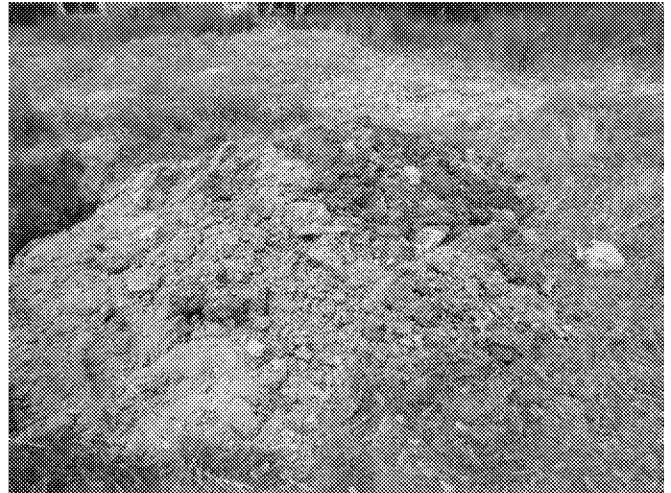
Photo 7b. West view of excavated soil at Test Pit B. Note Large cobbles excavated from Test Pit B.

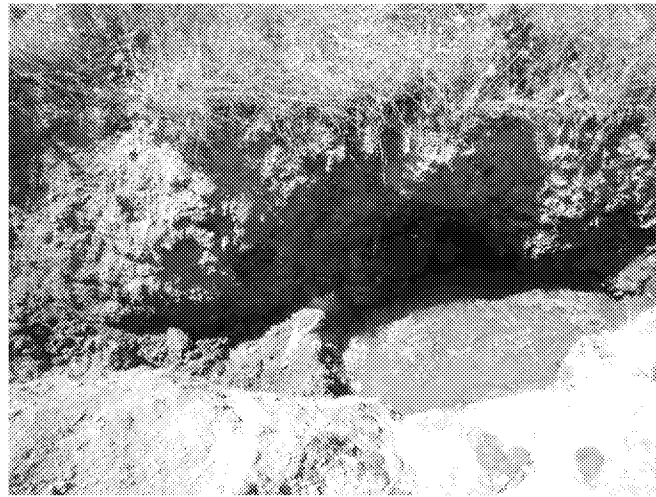
Photo 7c. Concrete in Test Pit B.

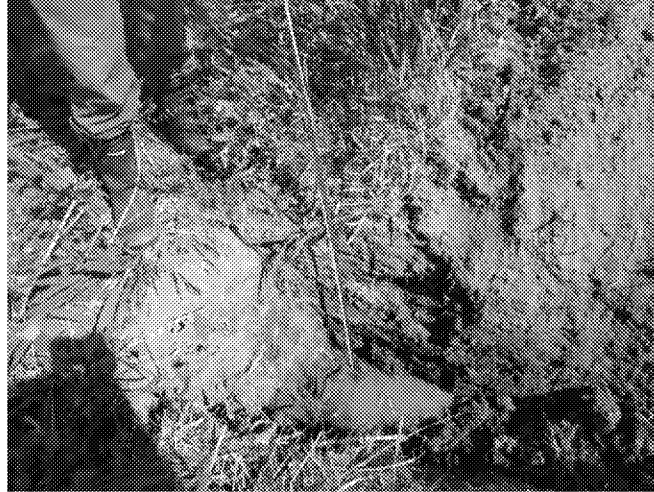
Photo 8a. Close-up of Test Pit C profile.

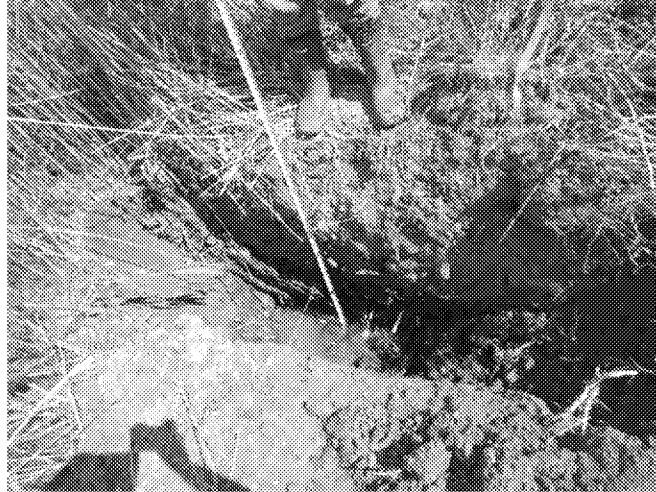
Photo 10a. Close-up of Test Pit E soil profile.

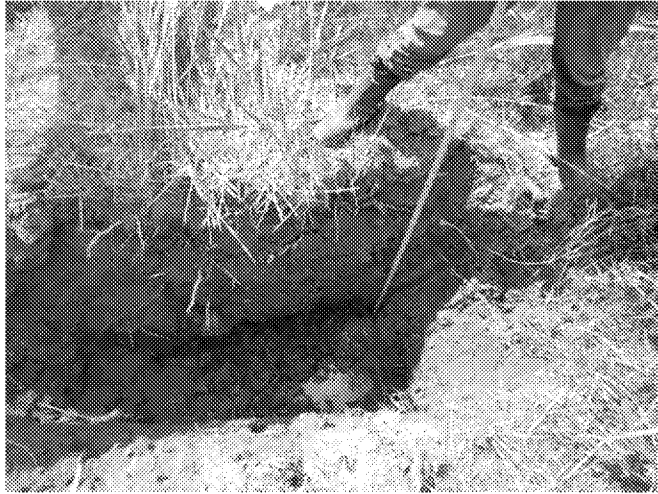
Photo 11a. Close-up of Test Pit F soil profile.

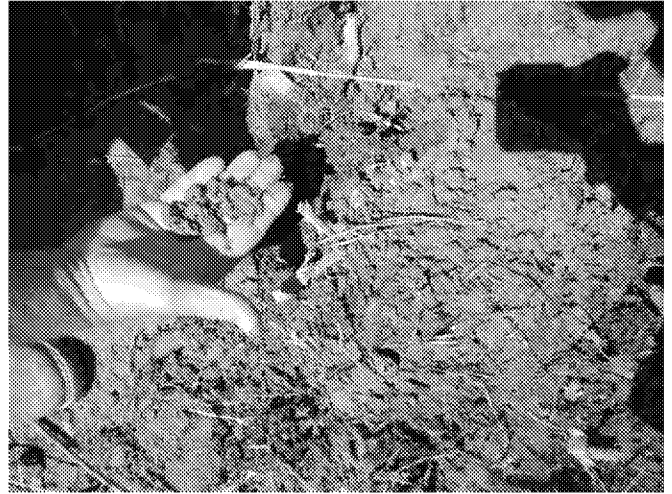
Photo 11b. Close-up of sand layer in Test Pit F at 3.5 ft. below surface.

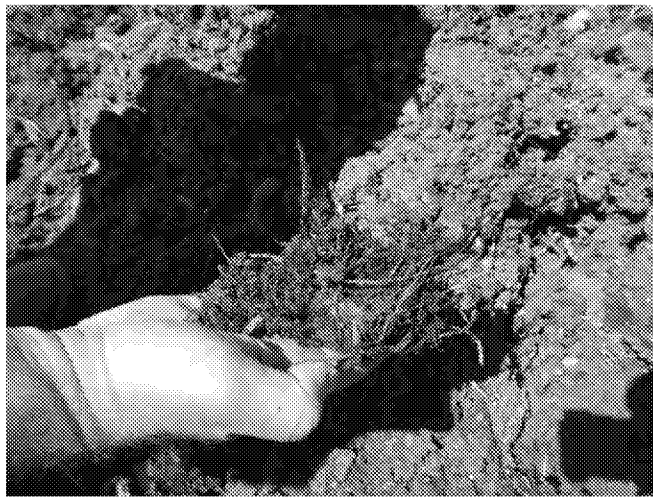
Photo 11c. Close-up of fibrous organic mat in Test Pit F at 2.7 ft. below surface.

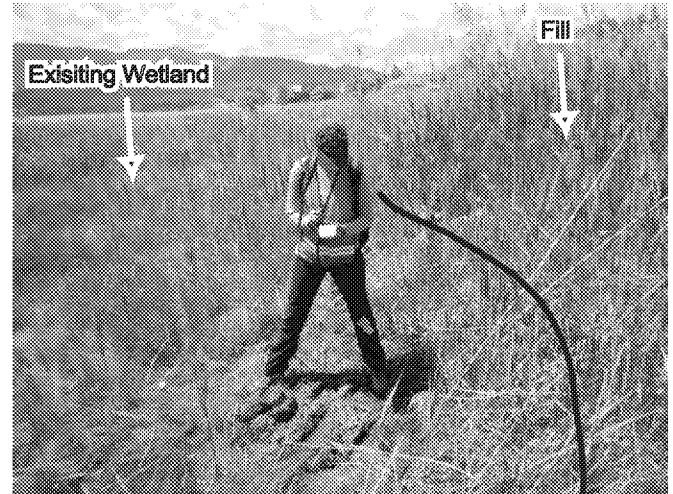
Photo 12b. West view of Fill boundary against existing wetland. Wetland is approximately 2-3 feet lower than top of fill removal area. Top of fill to be removed.

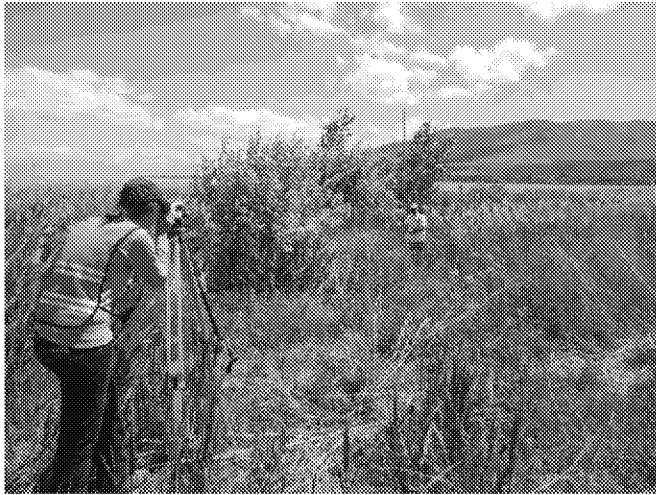
Photo 14. South west view of level station L2 on top of existing Harbor Dike.

- Frontier used an Engineers Level to estimate the approximate difference between the surface elevation of the fill removal area and the surface elevation of the adjacent existing wetlands. One level station (L1) was set-up on top of the fill removal area and one level station (L2) was set-up on top of the existing harbor dike. The locations of the level stations and surveyed reference points that were used to estimate differences in surface elevations are shown on Figure 2b. The approximate elevational differences relative to the level stations are also shown on Figure 2b. Elevation tables for the two level stations are provided in Appendix B.

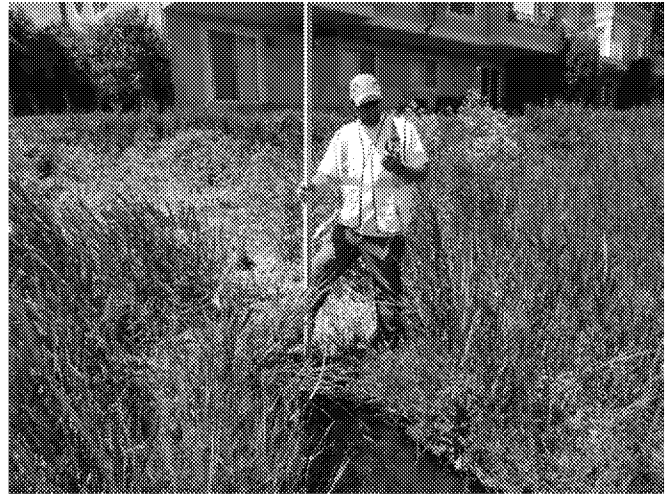
Photo 15. North west view of Outlet Pipe that feeds the flowing stream.

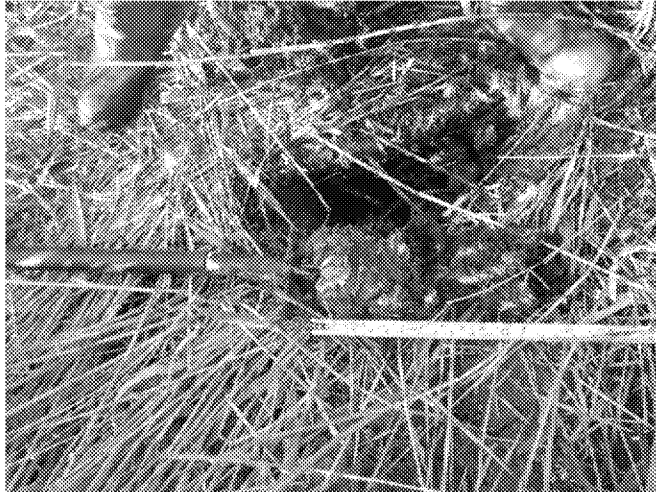
Wetland sample point 1A (SP1A). Close-up of wetland soil profile.

Profile Description: (Describe to the depth needed to document the indicator or confirm the absence of indicators.)							WETLAND	
Depth (inches)	Matrix		Redox Features				Texture	Remarks
	Color (moist)	%	Color (moist)	%	Type ¹	Loc ²		
0-4	10YR 5/2	100	10YR 4/6	5	C	PL	Silty sand	5% redox, saturated
4-8	GLE Y 1 2.5/N	50					Silt loam	Saturated
	2.5Y 2.5/1	50					Silt loam	Saturated
8-15	GLE Y 1 2.5/N	40					Silt loam	20% Gravel
	2.5Y 2.5/1	40					Silt loam	
15-18+	2.5Y 3/1	60					Silt loam	40% Gravel

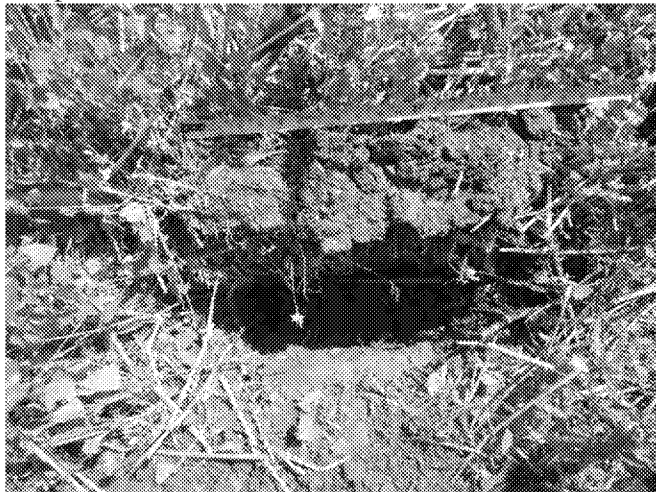
Upland sample point 1B (SP1B). Close-up of upland soil profile.

Profile Description: (Describe to the depth needed to document the indicator or confirm the absence of indicators.)						UPLAND	
Depth (inches)	Matrix		Redox Features			Texture	Remarks
	Color (moist)	%	Color (moist)	%	Type ¹		
0-4	10YR 4/3	100					Sandy/Silt loam Fibrous root zone
4-5	7.5YR 5/4	100					Sandy/Silt loam Dry, no redox
5-18+	7.5YR 5/4	20					Sandy/Silt loam Dry, no redox
	10YR 4/3	80					Sandy/Silt loam Dry, no redox

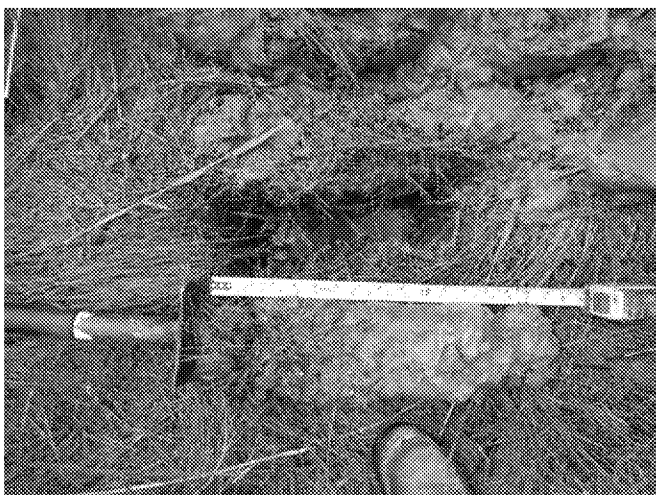
Wetland sample point (SP2A). Close-up of wetland soil profile.

Profile Description: (Describe to the depth needed to document the indicator or confirm the absence of indicators.)						WETLAND		
Depth (inches)	Matrix		Redox Features			Texture	Remarks	
	Color (moist)	%	Color (moist)	%	Type ¹			Loc ²
0-4	10YR 4/1	100					Sandy loam	Root zone
4-12	2.5Y 5/1	100					Loam	Saturated
12-19	2.5Y /61	100					Gravel/Clay	Saturated

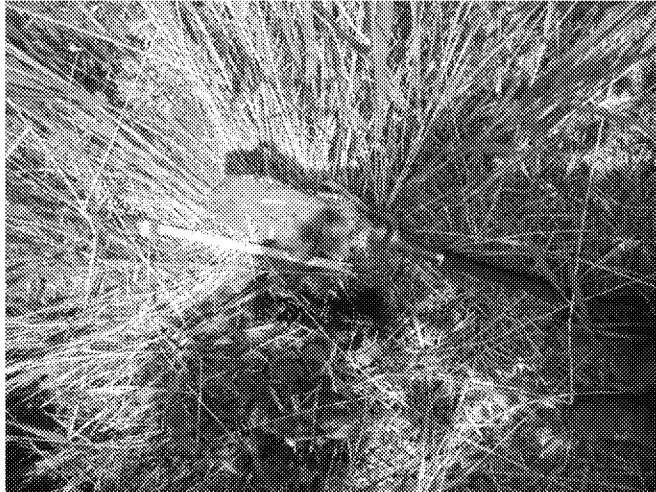
Upland sample point 2B (SP2B). Close-up of upland soil profile.

Profile Description: (Describe to the depth needed to document the indicator or confirm the absence of indicators.)						UPLAND	
Depth (inches)	Matrix		Redox Features			Texture	Remarks
	Color (moist)	%	Color (moist)	%	Type ¹		
0-6	10YR 5/3	100					Sand/Gravel/Silt Dry
6-18	10YR 5/6	100					Silt loam Dry
18-20+	2.5Y 4/1	100					Clay Charcoal found, moist

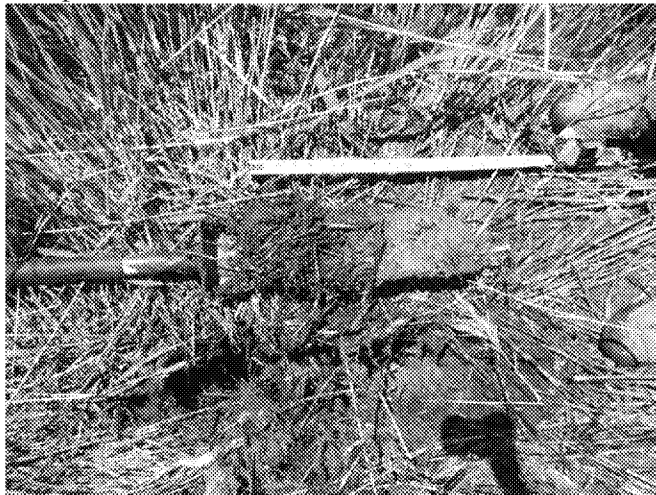
Wetland sample point 3A(SP3A). Close-up of wetland soil profile.

Profile Description: (Describe to the depth needed to document the indicator or confirm the absence of indicators.)						WETLAND	
Depth (inches)	Matrix		Redox Features			Texture	Remarks
	Color (moist)	%	Color (moist)	%	Type ¹		
0-7	5Y 2.5/1	100					Silt loam Root zone
7-14+	10YR 5/1	80					Clay 20% gravel
14-18+	10YR 5/1	90					Sand Root layer from 14"-15"
							10% gravel

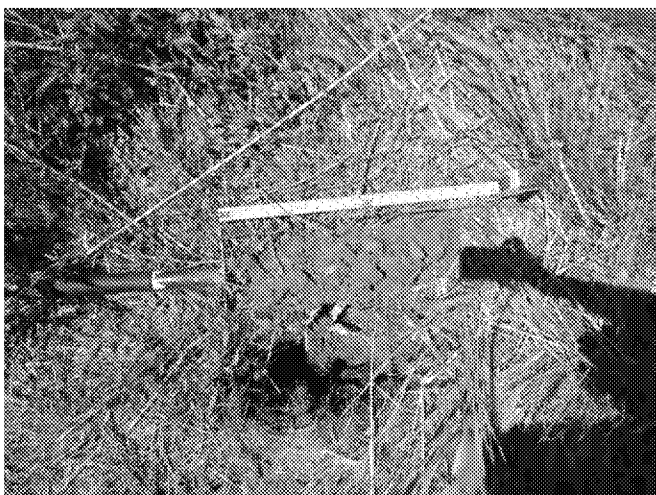
Upland sample point 3B(SP3B). Close-up of upland soil profile.
